FULL RESERVE STUDY

Wisteria Park Homeowners Association, Inc.

**Bradenton, Florida
April 19, 2017**

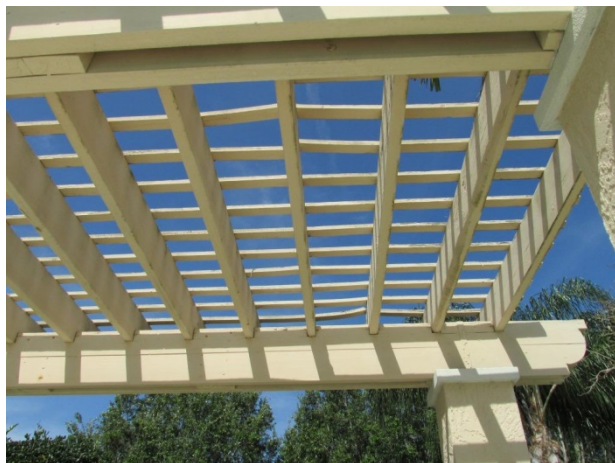
Condition: Fair

Warped wood at arbor

Expenditure Detail Notes: Expenditure timing and costs are depicted in the **Reserve Expenditures** table in Section 3. The estimate of cost reflects replacement with aluminum.

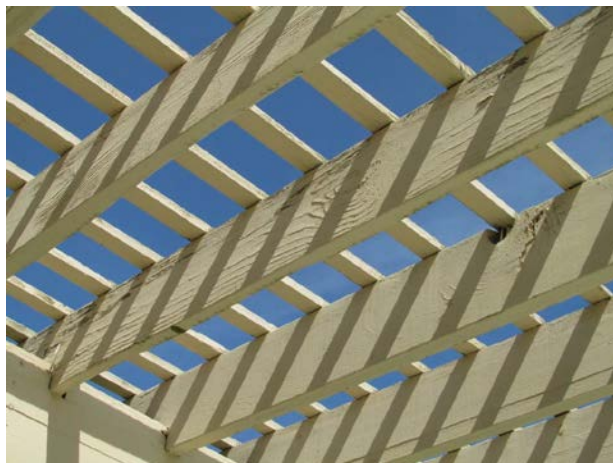
Peeling paint at wood arbor

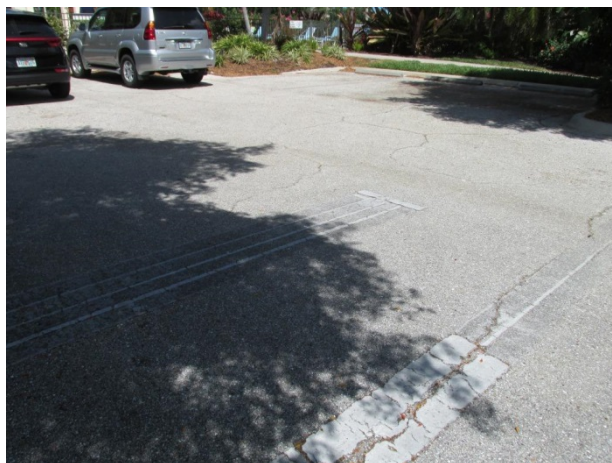
Condition: Good to fair overall with cracks evident

Note cracks at asphalt pavement parking area

followed by the application of two or more new lifts of asphalt. We recommend mill and overlayment on asphalt pavement that exhibits normal deterioration and wear. We recommend total replacement of asphalt pavement that exhibits severe deterioration, inadequate drainage, pavement that has been overlaid multiple times in the past or where the configuration makes overlayment not possible. Based on the apparent visual condition and configuration of the asphalt pavement, we recommend the total replacement method of repaving at Wisteria Park.

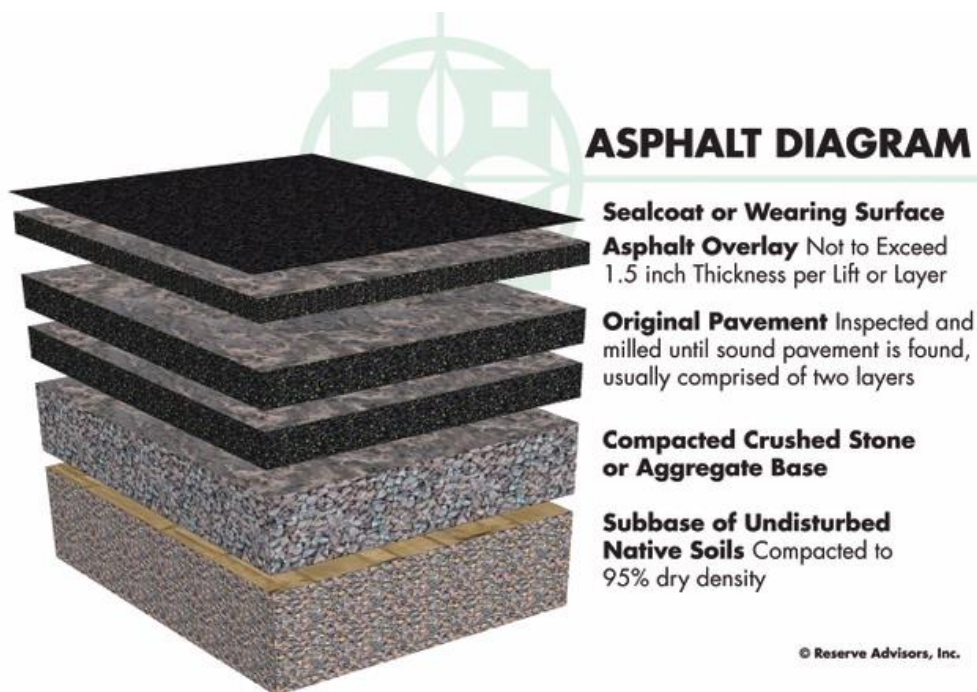
Component Detail Notes: The initial installation of asphalt uses at least two lifts, or two separate applications of asphalt, over the base course. The first lift is the binder course. The second lift is the wearing course. The wearing course comprises a finer aggregate for a smoother more watertight finish. The following diagram depicts these components:

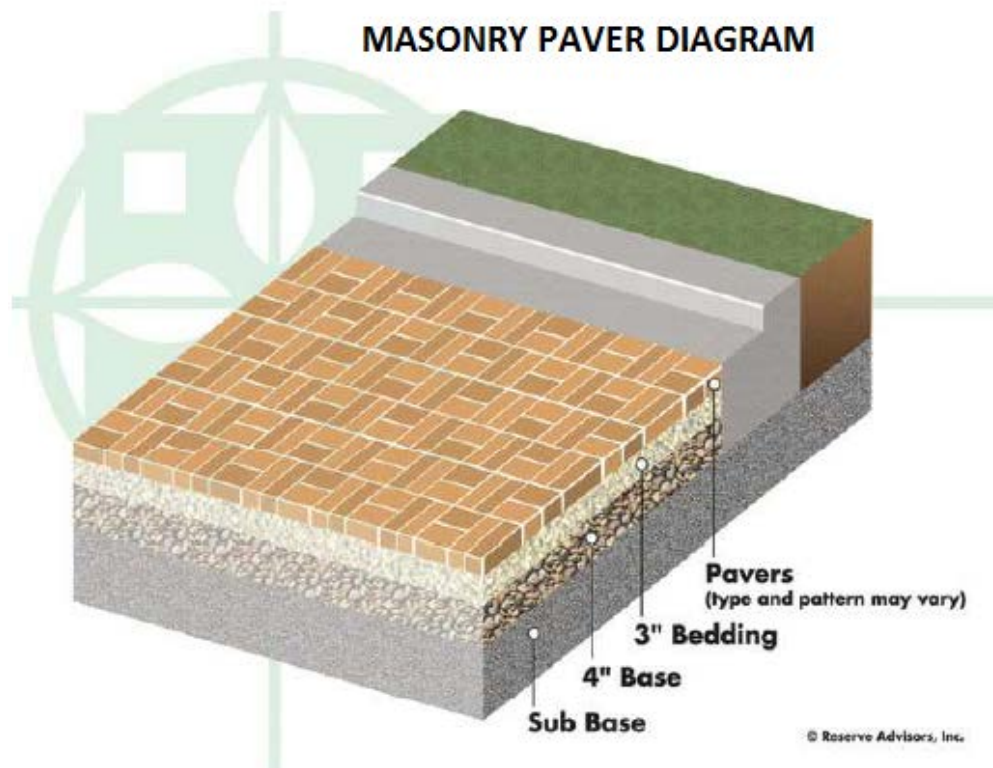
Component Detail Notes: The following diagram depicts the components of a masonry paver system:

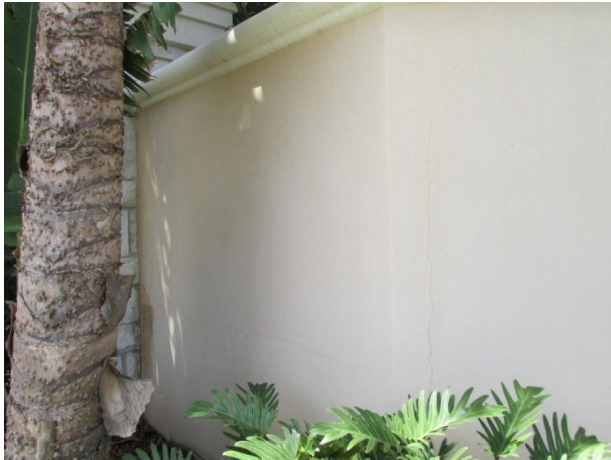
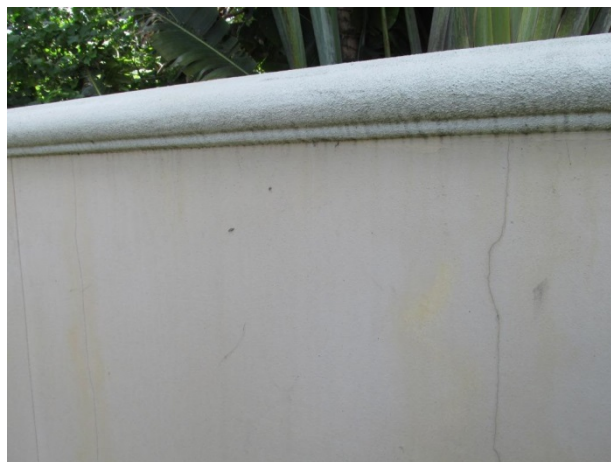
Condition: The walls are in good condition overall and paint finish is in fair condition overall with cracks and vegetation cover evident.

Perimeter wall with cracks noted

Expenditure Detail Notes: Expenditure timing and costs are depicted in the **Reserve Expenditures** table in Section 3. Our estimate of cost anticipates repair or replacement of 170 square feet, or up to one percent (1%), of the stucco in coordination with each paint finish application. The exact amount of area in need of repair will be discretionary based on the actual future conditions and the desired appearance. Each paint product has the limited ability to cover and seal cracks but we recommend repair of all cracks which exceed the ability of the paint product to bridge.

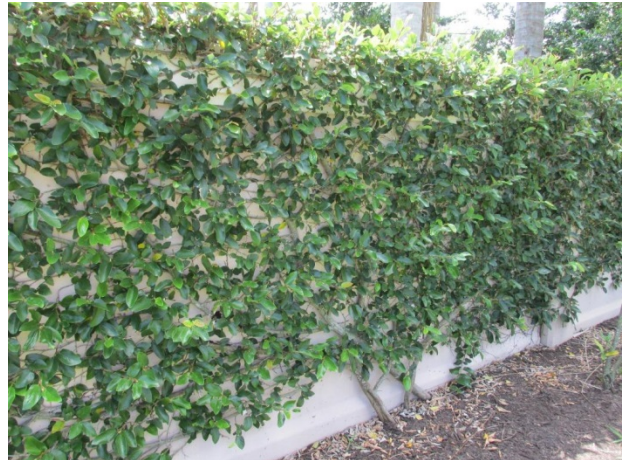
Vegetation cover at perimeter wall

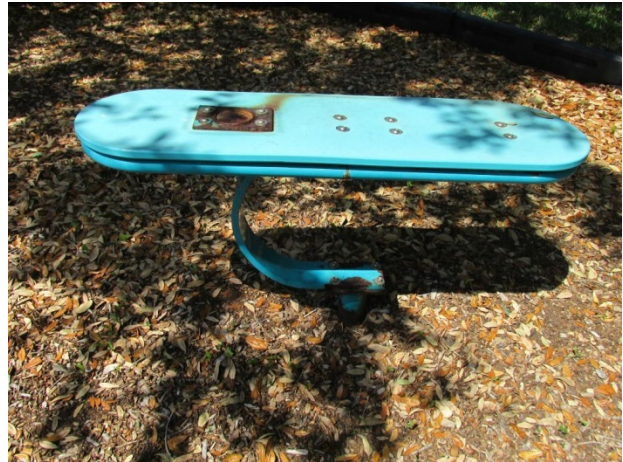
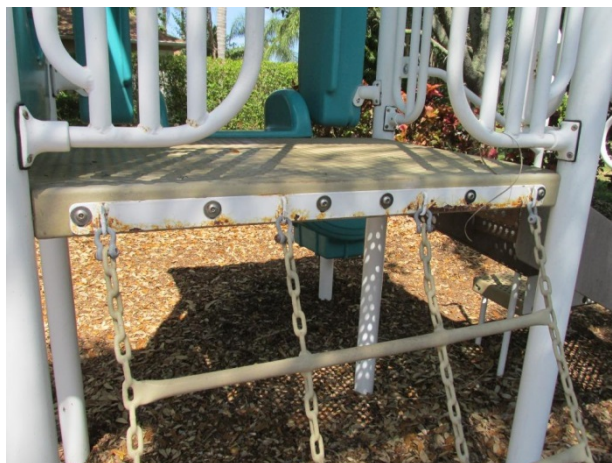
Condition: Fair to poor overall with rust evident

Rust evident at playground equipment

- Replacement of the playground equipment by 2018

Expenditure Detail Notes: Expenditure timing and costs are depicted in the **Reserve Expenditures** table in Section 3. We include an allowance in the unit cost for replacement of the safety surface.

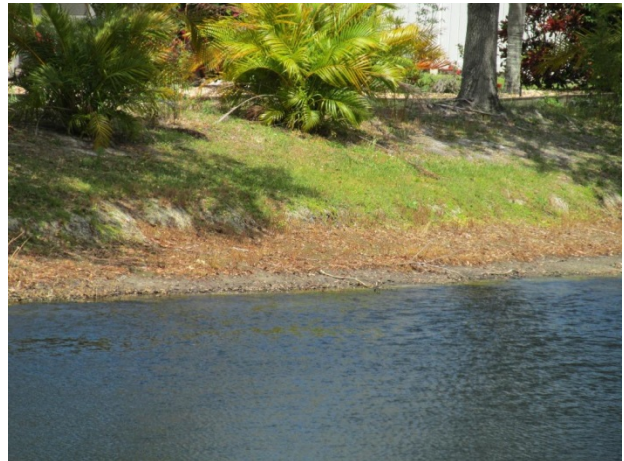
Condition: The shorelines appear in good condition with only minor erosion noted.

Minor erosion noted at shoreline of Pond 1

Expenditure Detail Notes: Expenditure timing and costs are depicted in the **Reserve Expenditures** table in Section 3. We recommend the Association plan to install a combination of plantings and rip rap around the ponds along 600 linear feet, or approximately ten percent (10%), of the shorelines.

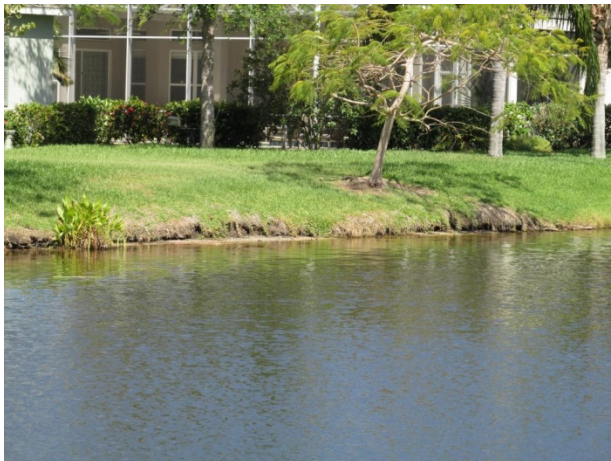
Minor erosion noted at shoreline of Pond 3

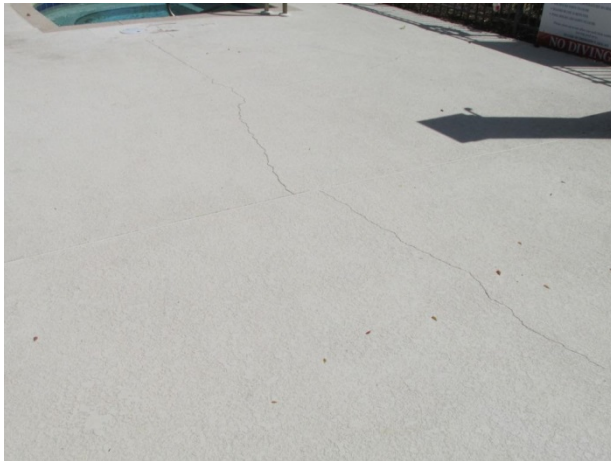
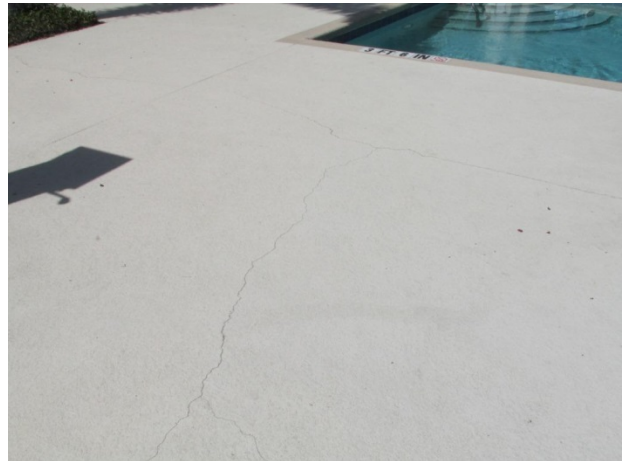
Condition: Good to fair condition with hairline cracks evident

Note hairline cracks in deck

- Selective cut out and replacements of up to ten percent (10%) of concrete
- Crack repairs as needed
- Mortar joint repairs
- Caulk replacement
- Coating replacement
